**Conceptual Restoration Plan
Active Floodplain of the Rio Grande
San Acacia to San Marcial, NM**

Volume 1 of 4

Final Draft Report

Prepared by:
Tetra Tech, Inc.
ISG, Surface Water Group

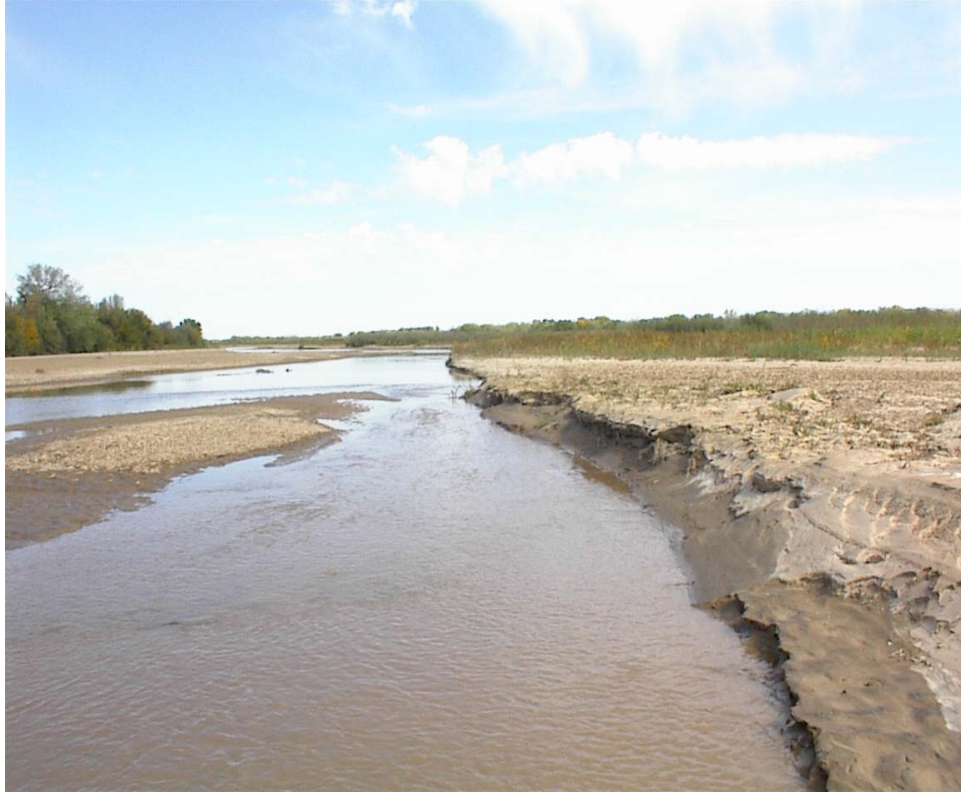
Photo 1. Lateral Erosion of Sand Bars during the Fall

Moderate flows in the fall can provide energy for reworking the channel sand bars. The sand bars are reworked by lateral erosion bars as the small channels move back and forth across the river bed. The sand bars may be positioned one to two feet higher than the water surface and the braided flow paths result in varying angles of attack on the margins of the bars (Photo 1). The small sand bar vertical banks are undermined and collapse into the flow. Lateral erosion may proceed at a rate of a half foot per hour. Often the flow against the bars occurs only for a portion of the day before shifting away from the bar. Seedling growth on the bars can be removed through this bar erosion process.

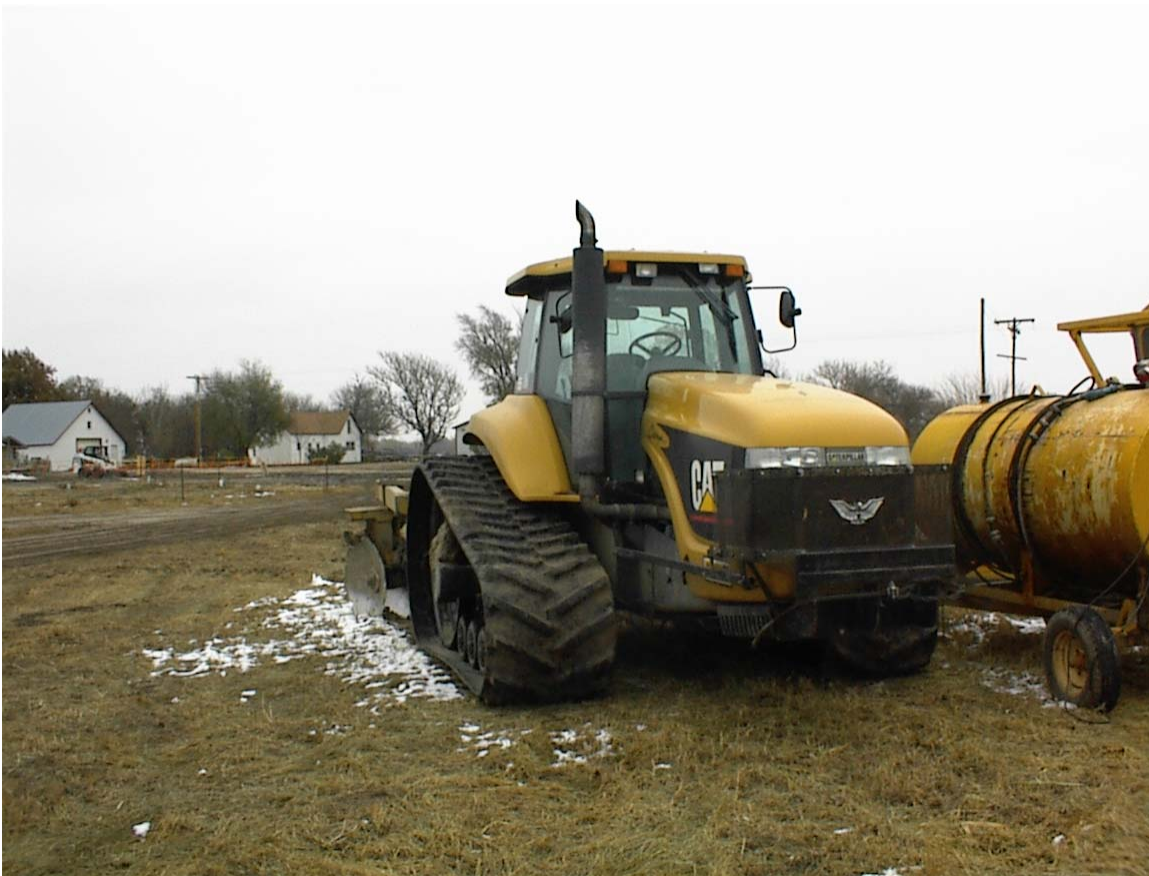
Photo 2. Whooping Crane Trust Tractor Used on the Platte River, Nebraska

1. Mow and disc sand bar vegetation – Vegetation growing on river sand bars can be cut with mowers up to a height of about 4 ft. This would constitute a vegetation age group of 2 years or less. Reworking the sand bars would be accomplished with an appropriate tractor such as a Challenger operating a mower and disc. The disc should be large enough to rework the vegetation root system requiring disc blades of 18 to 24 inches in diameter. Annual occurrence of appropriate spring flushing flows and fall maintenance flows will minimize the required reworking of the sand bars.

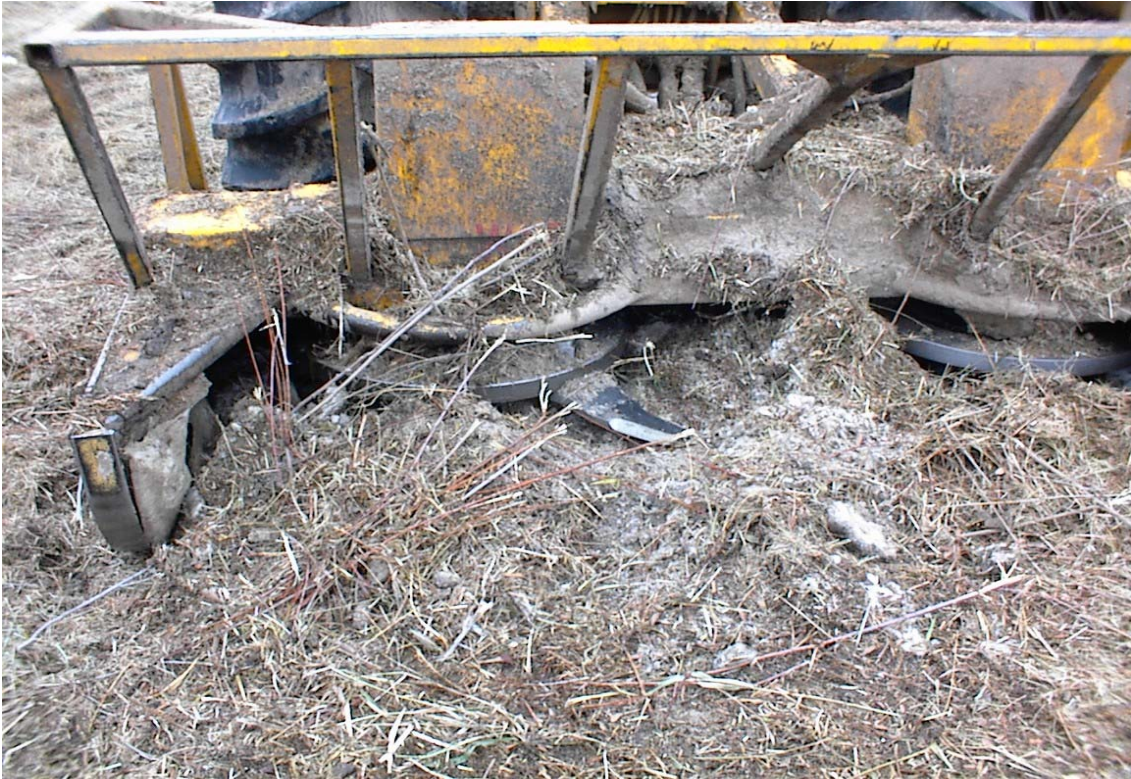
Photo 3. Mower for the Trust Tractor

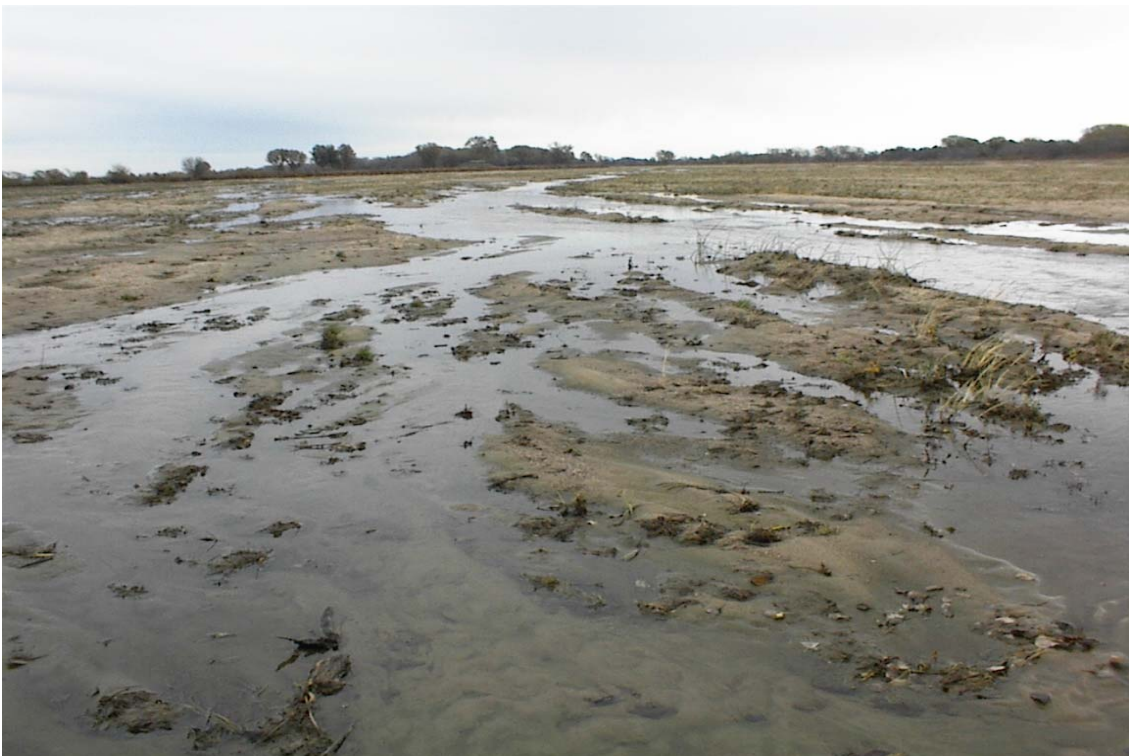
Photo 4. Platte River, Nebraska Recently Mowed and Disked

The high percent of fine sediment depositions in the Rio Grande may present a challenge in reworking the sand bars. Mowing and disking should be accomplished with tandem vehicles for support when one vehicle is mired.
